Appendix B - Photographs

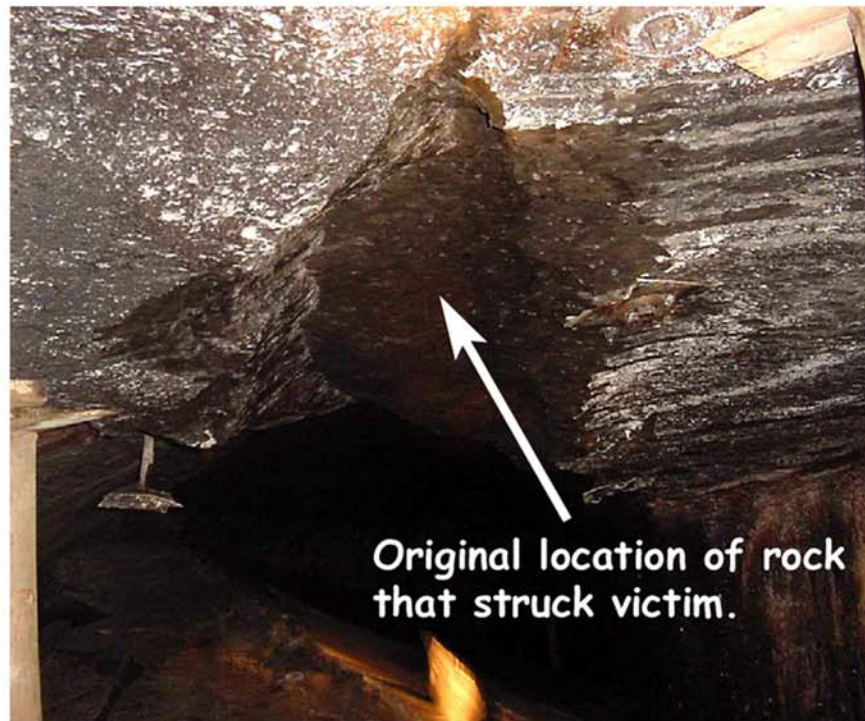
Figure 2 - This image shows the portion of the roof fall that extended back from the unsupported working place through the roof bolts.

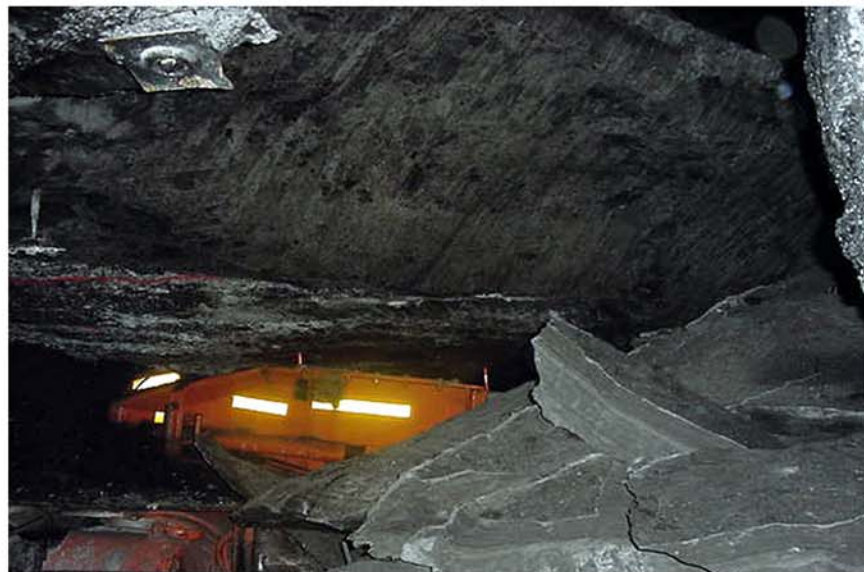
Figure 3 - This image shows the perspective from the No.7 entry. The high angled slickensided face (with moist clay layer) of Slip #1 is visible above the miner boom.
